AUCKLAND CASTLE **ENABLING WORKS FOR SCOTLAND WING EXTENSION**

Client – Auckland Castle Trust – xxxxxxxxxxxxxxxx
📍 Auckland Castle, Bishop Auckland, Co Durham, DL14 7NR
☎ xxxxxxxxxxxxxxxx ✉ xxxxxxxxxxxxxxxx

Completion – June 2016 (4 Months)

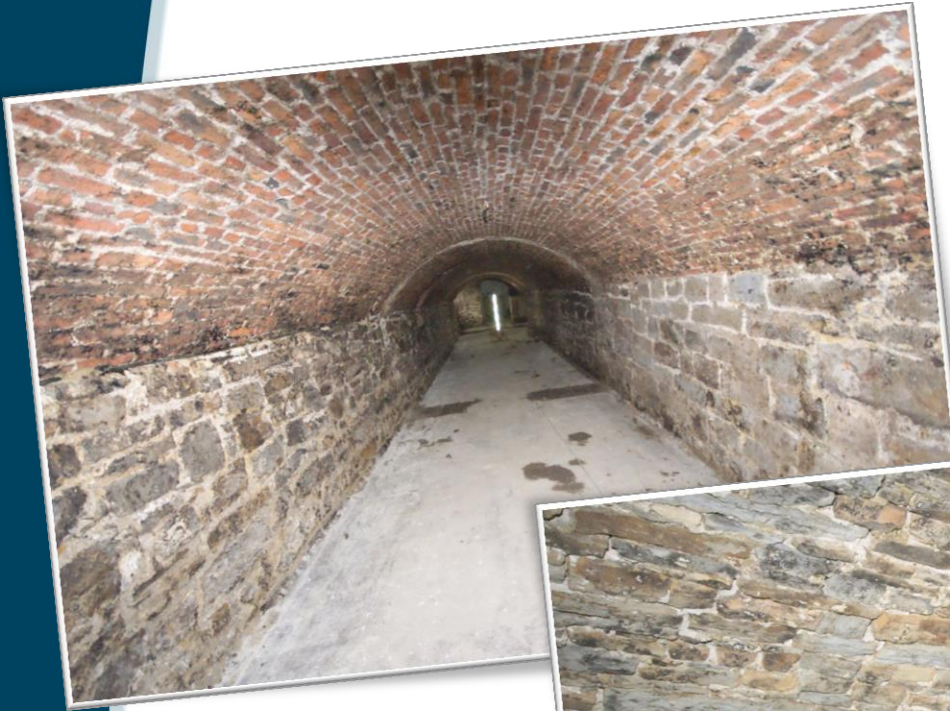
The Walls after the existing plaster & bitumen was removed.

Removal of Plaster & Bitumen – The plaster from the ground floor was removed by machine and was originally planned to be removed in 3 stages. However once we commenced works the original system failed to be effective. We then worked with our specialist and the design team to develop a new 4 stage system after carrying out a series of sample panels using various techniques. On the first floor the plaster was removed by hand.

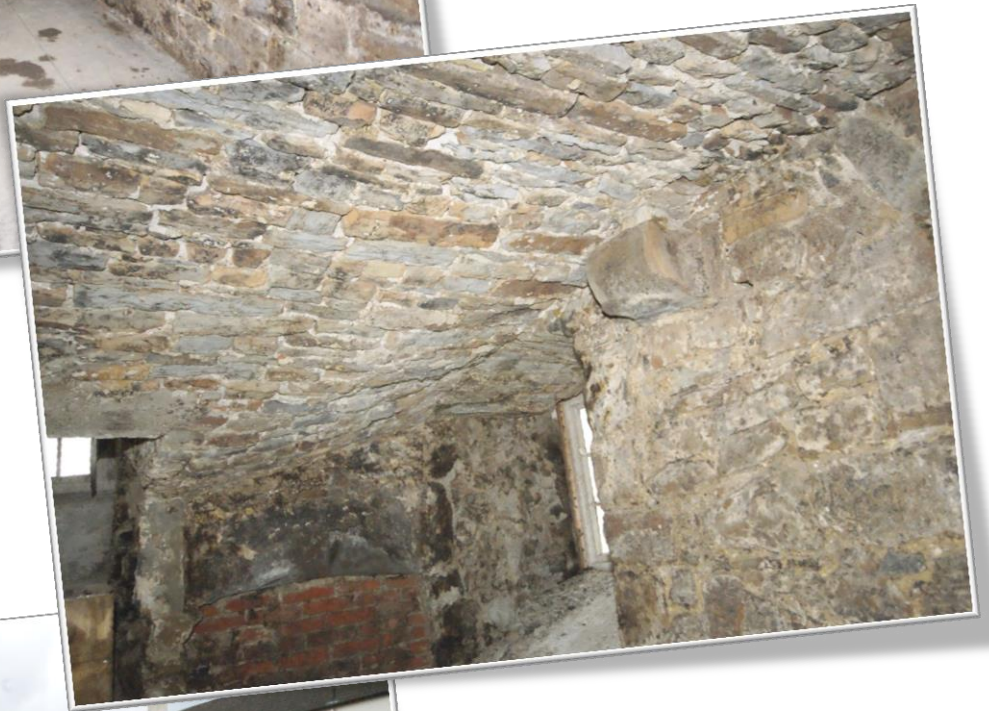
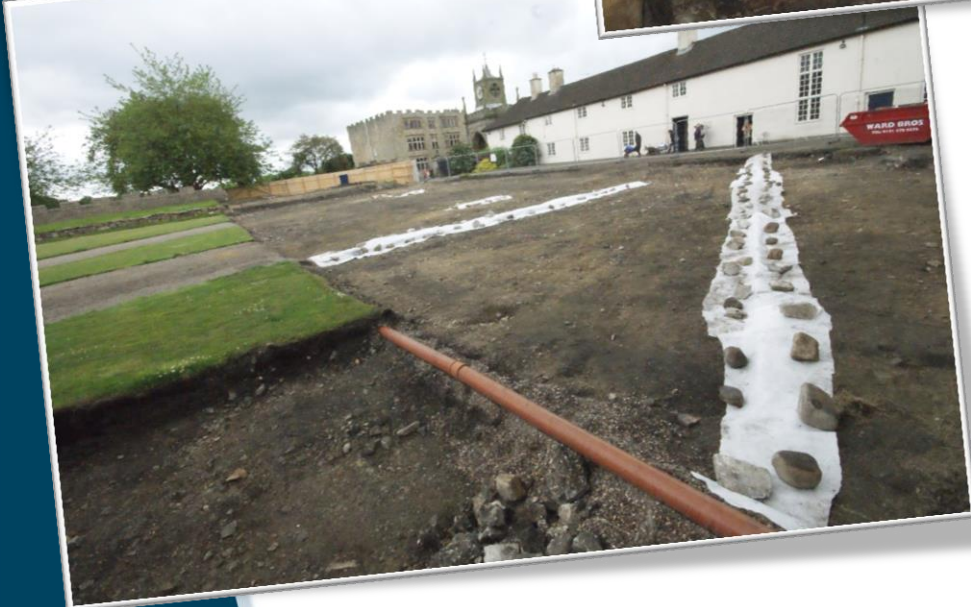
Photo showing the archaeological excavation. The existing/discovered features were recorded and protected during the works.
