## BARRAS BUILDING NEWCASTLE UNIVERSITY

Completion – August 2015 (12 Months)

Value - £840,000 (*JCT Measured Term Contract 2011*)

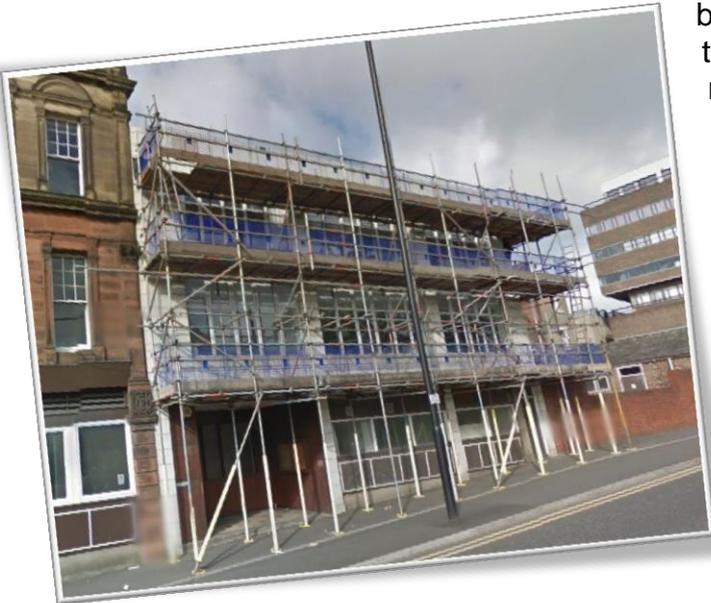
Upon opening up the building we found that there was significant corrosion to not only the supporting brackets, but also to the structural steel frame. We also discovered that the cast in situ roof slab was very thin and its reinforcement heavily corroded thus resulting in spalling concrete and a deck which was no longer structurally stable.
